United States Department of the Interior
National Park ServiceNational Register of Historic Places
Registration Form

historic name Johnson, Wilbur T. and Rhoda Stephens, House
other names/site number Missouri State DAR Headquarters
Roslyn Heights, 0-32

street & number 821 Main N/A not for publication
city, town Boonville N/A vicinity
state Missouri code MO county Cooper code 053 zip code 65233

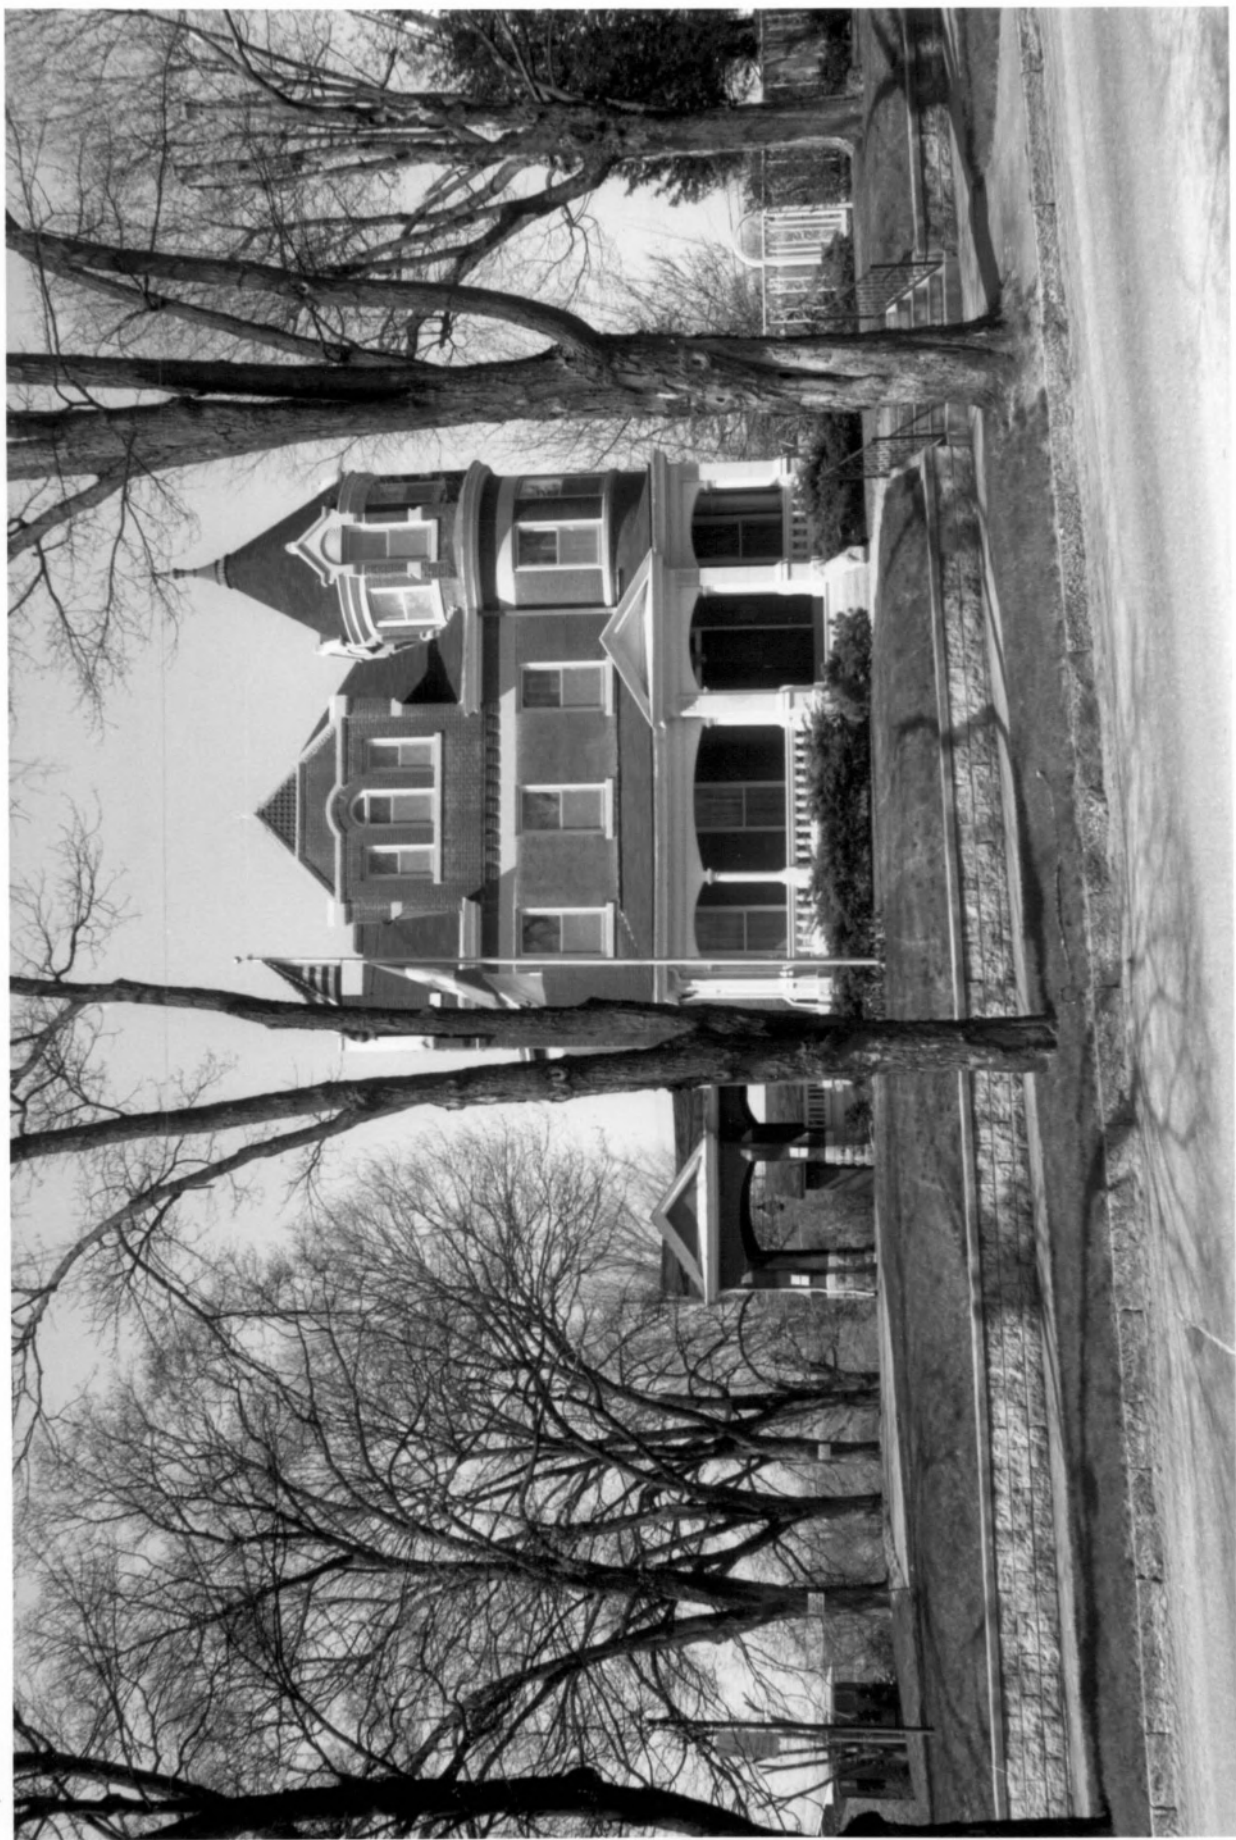
1 of 11

Missouri Cultural Resource Inventory
View from East

Outstanding features include a one-story hip roofed porch with pediment over a double leaf entrance and transom. Paneled front doors open from the front porch into a room-sized reception hall. The original storm doors have etched glass panes with the initials "WTJ" on each for Wilbur T. Johnson, the original owner. These doors open into a small entrance hall, and when left opened, flush with the entrance wall leading into the reception area, create one continuous wall. Moorish decorations embellish the doors in keeping with Moorish ornamentation found in the reception area. The hall has its original

decorative floor tile and an oak grained wall treatment simulates paneled walls. The gasoliers on the porch are original. The modified Doric composition of the porch is accented by Doric pilasters, gutae, and a severely plain entablature and pediment. The three bay second story features plain brick windows and common bond brick; the east elevation's major decorative accents are found on the first and third stories. Three part windows with arcaded headers accent a third floor dormer while windows on the third floor of the facade tower are capped by stone in a sunburst design.

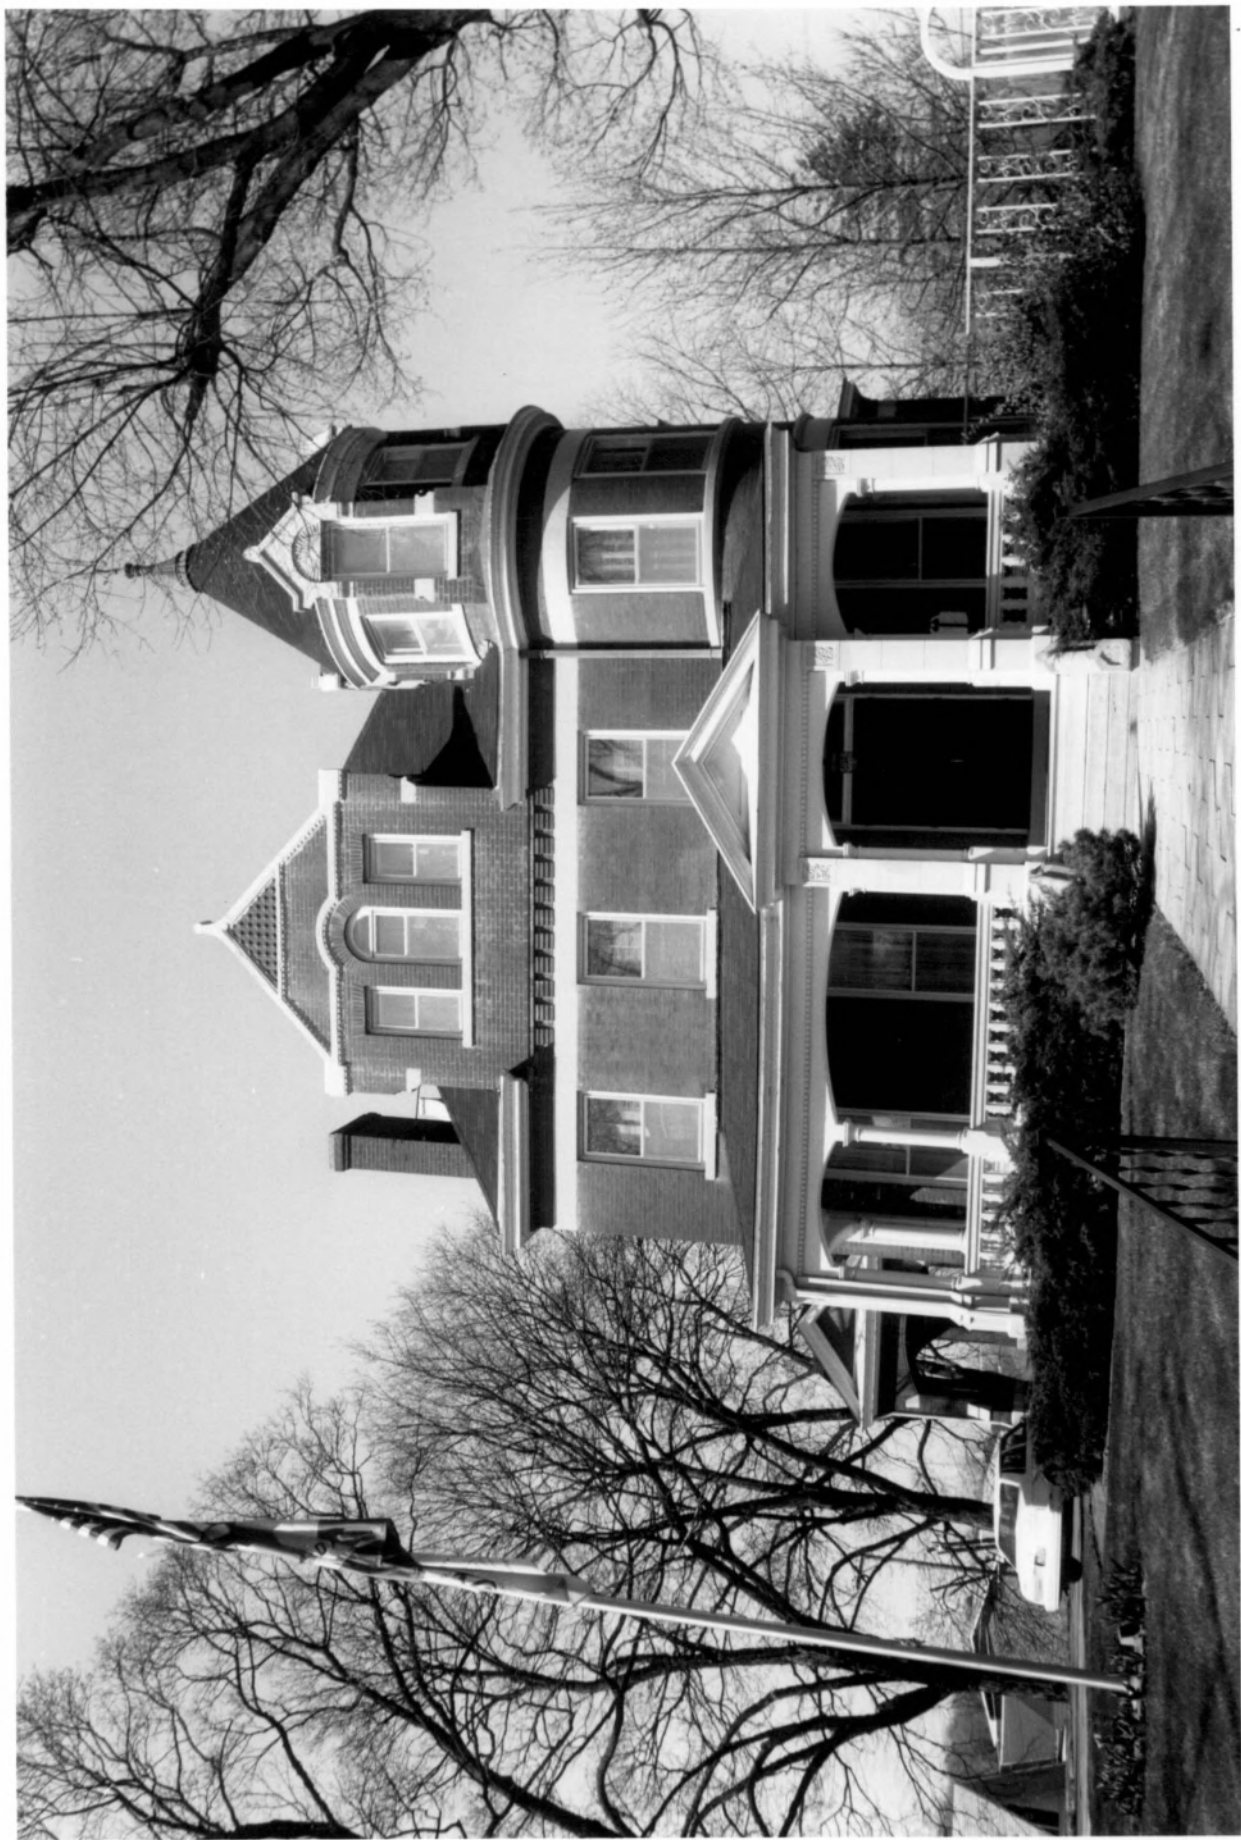
#2 of 11

View from East

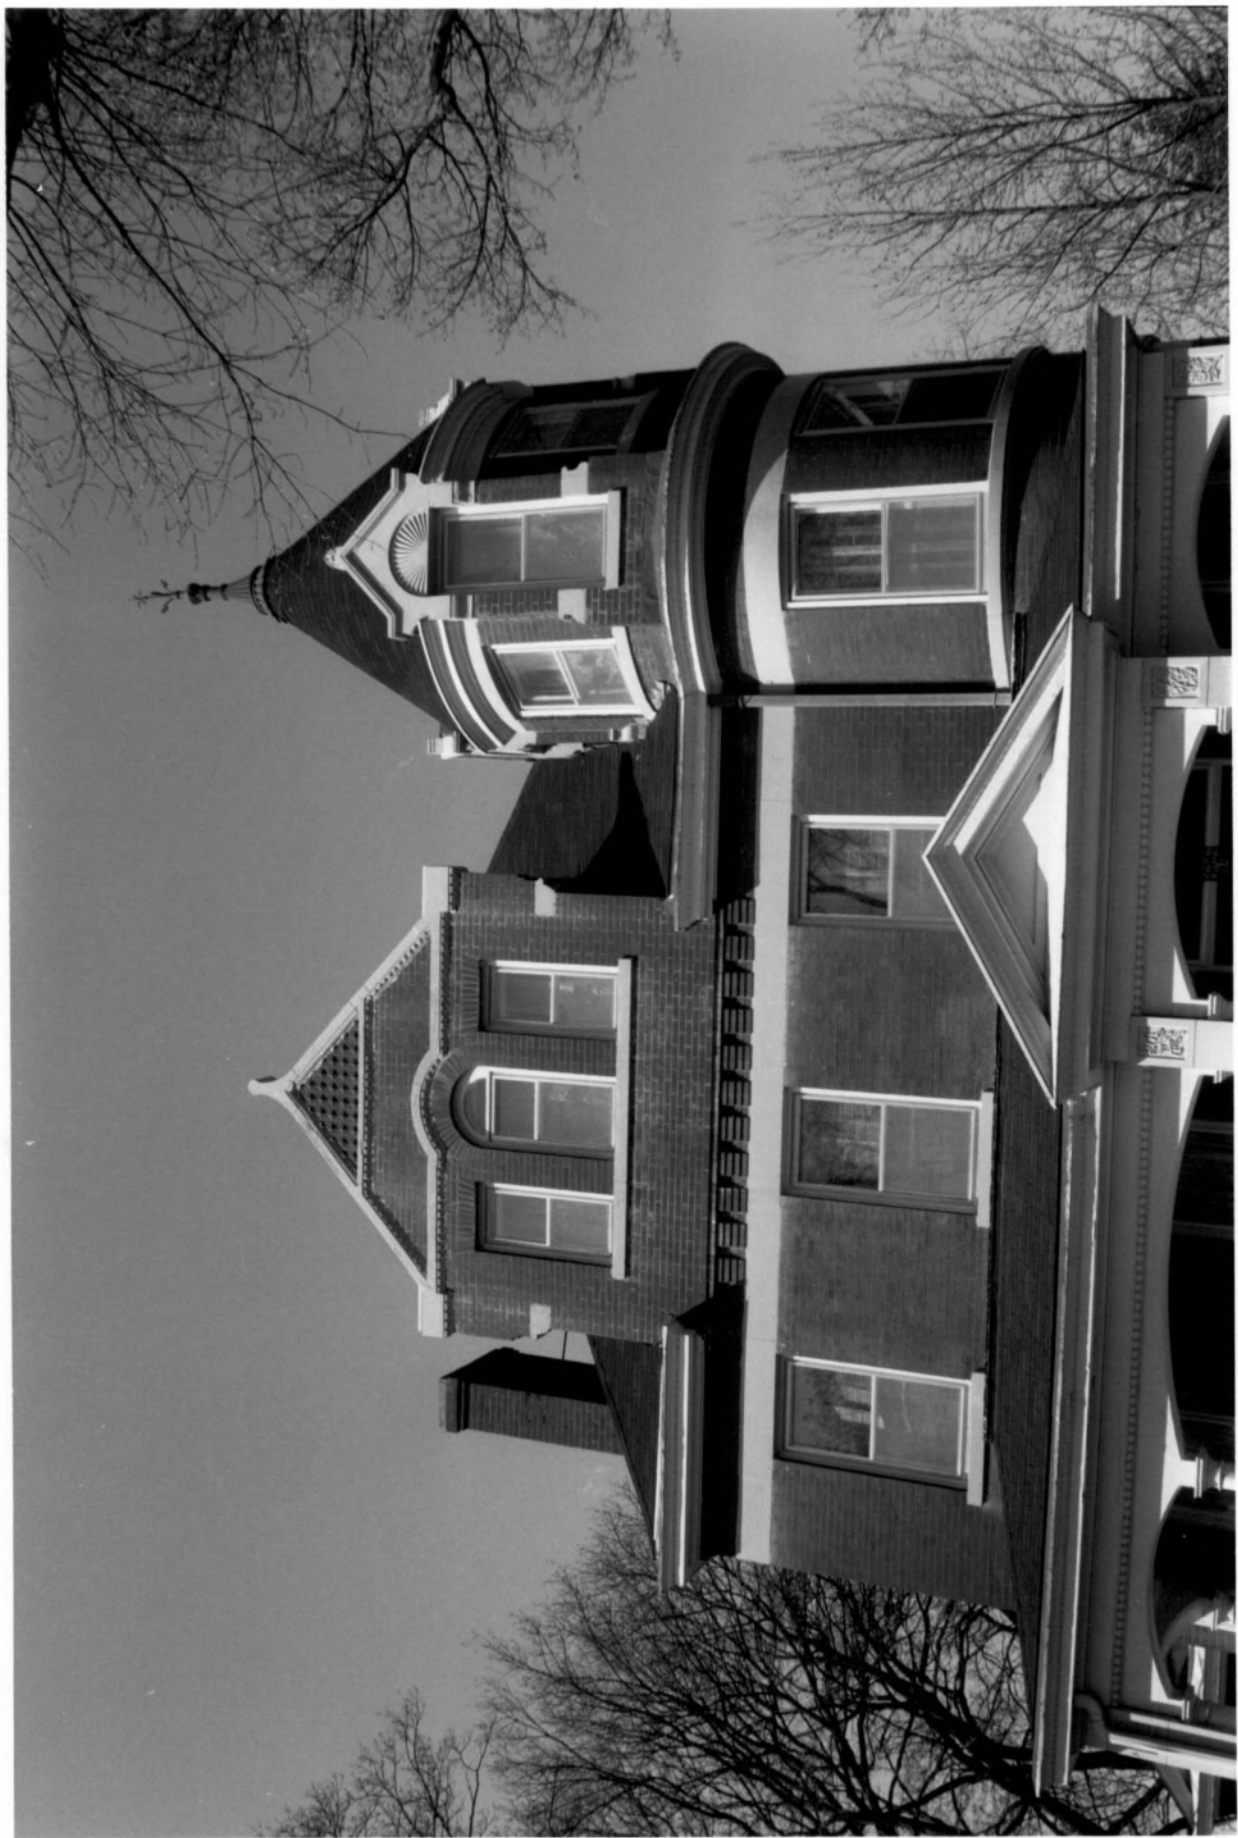
3 of 11

View of upper stories from East

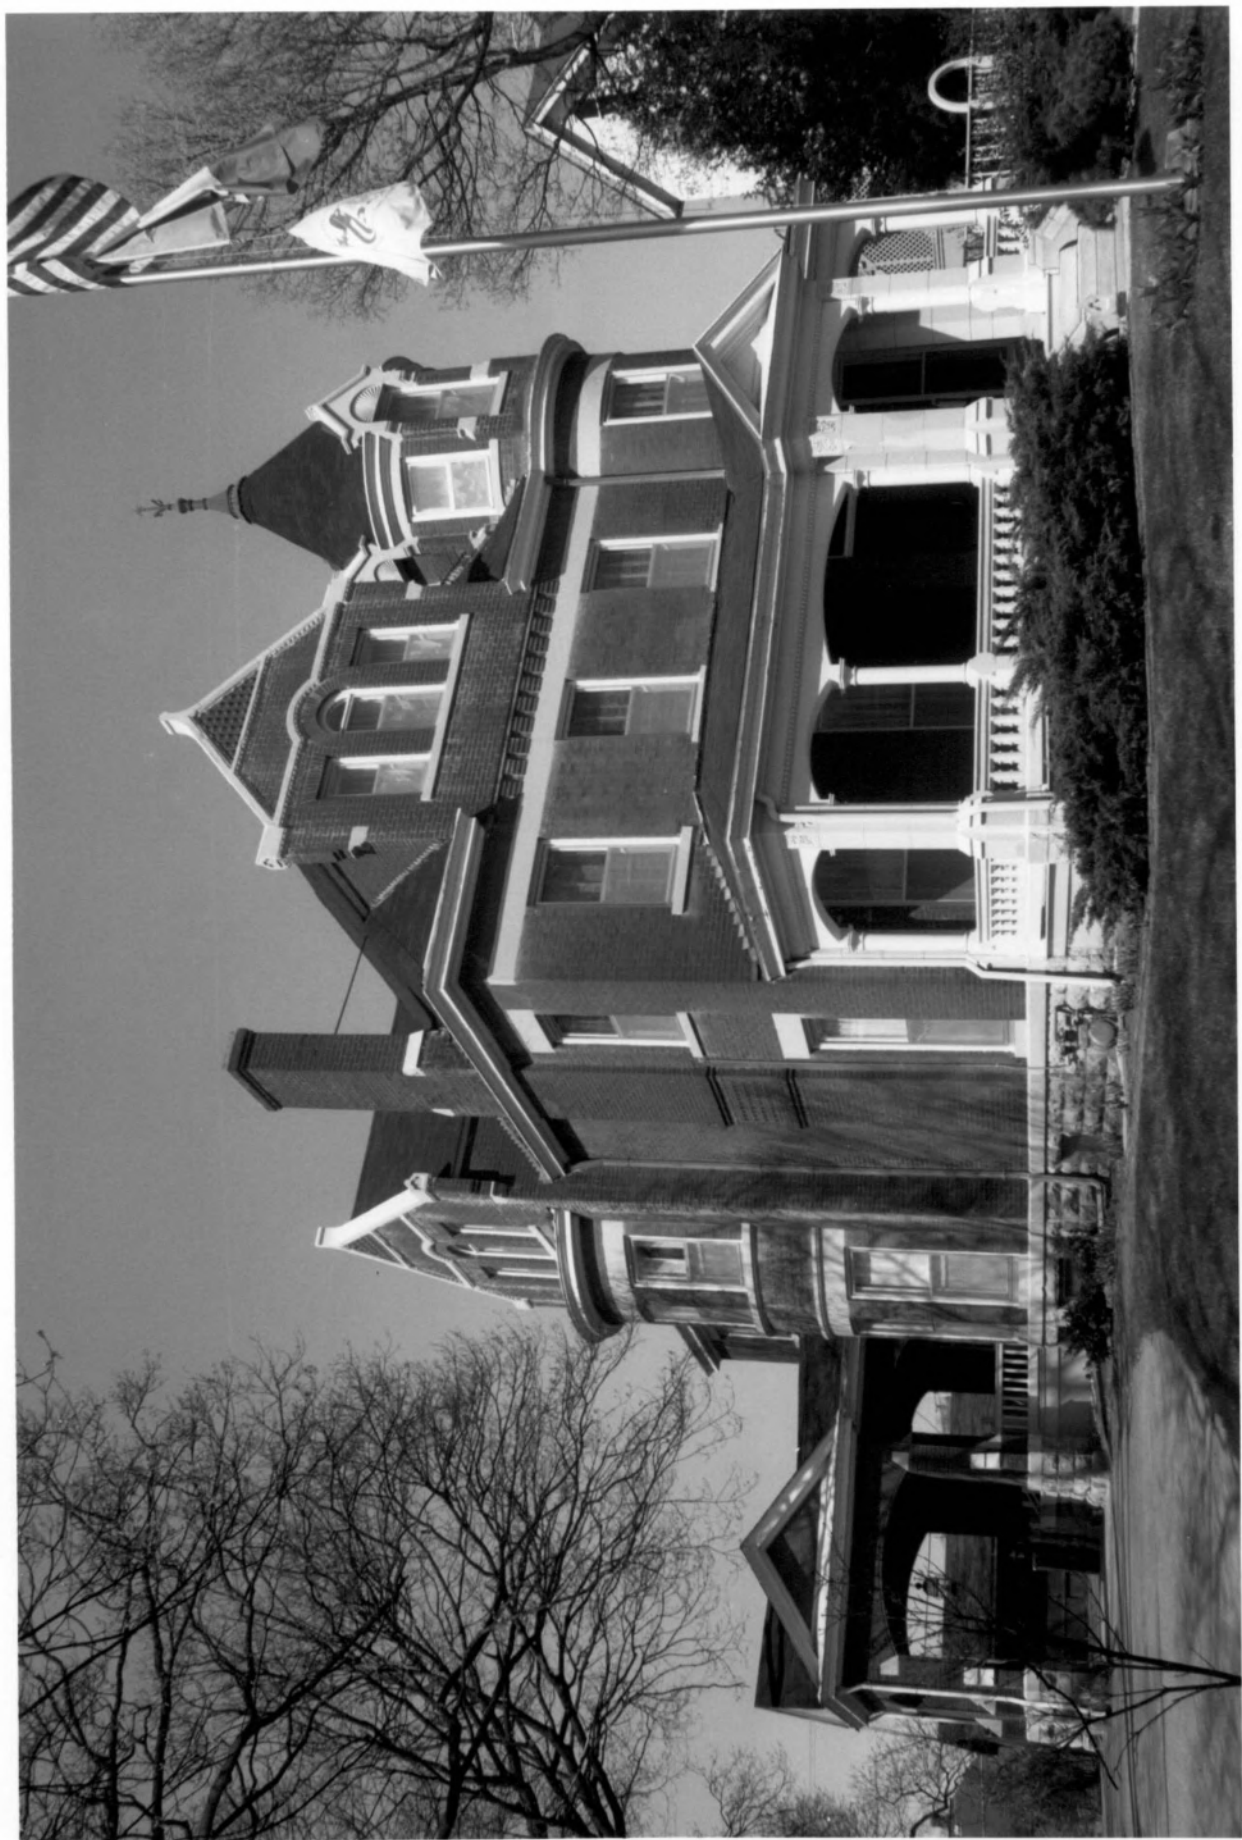
4 of 11

Missouri Cultural Resource Inventory
View from Southeast

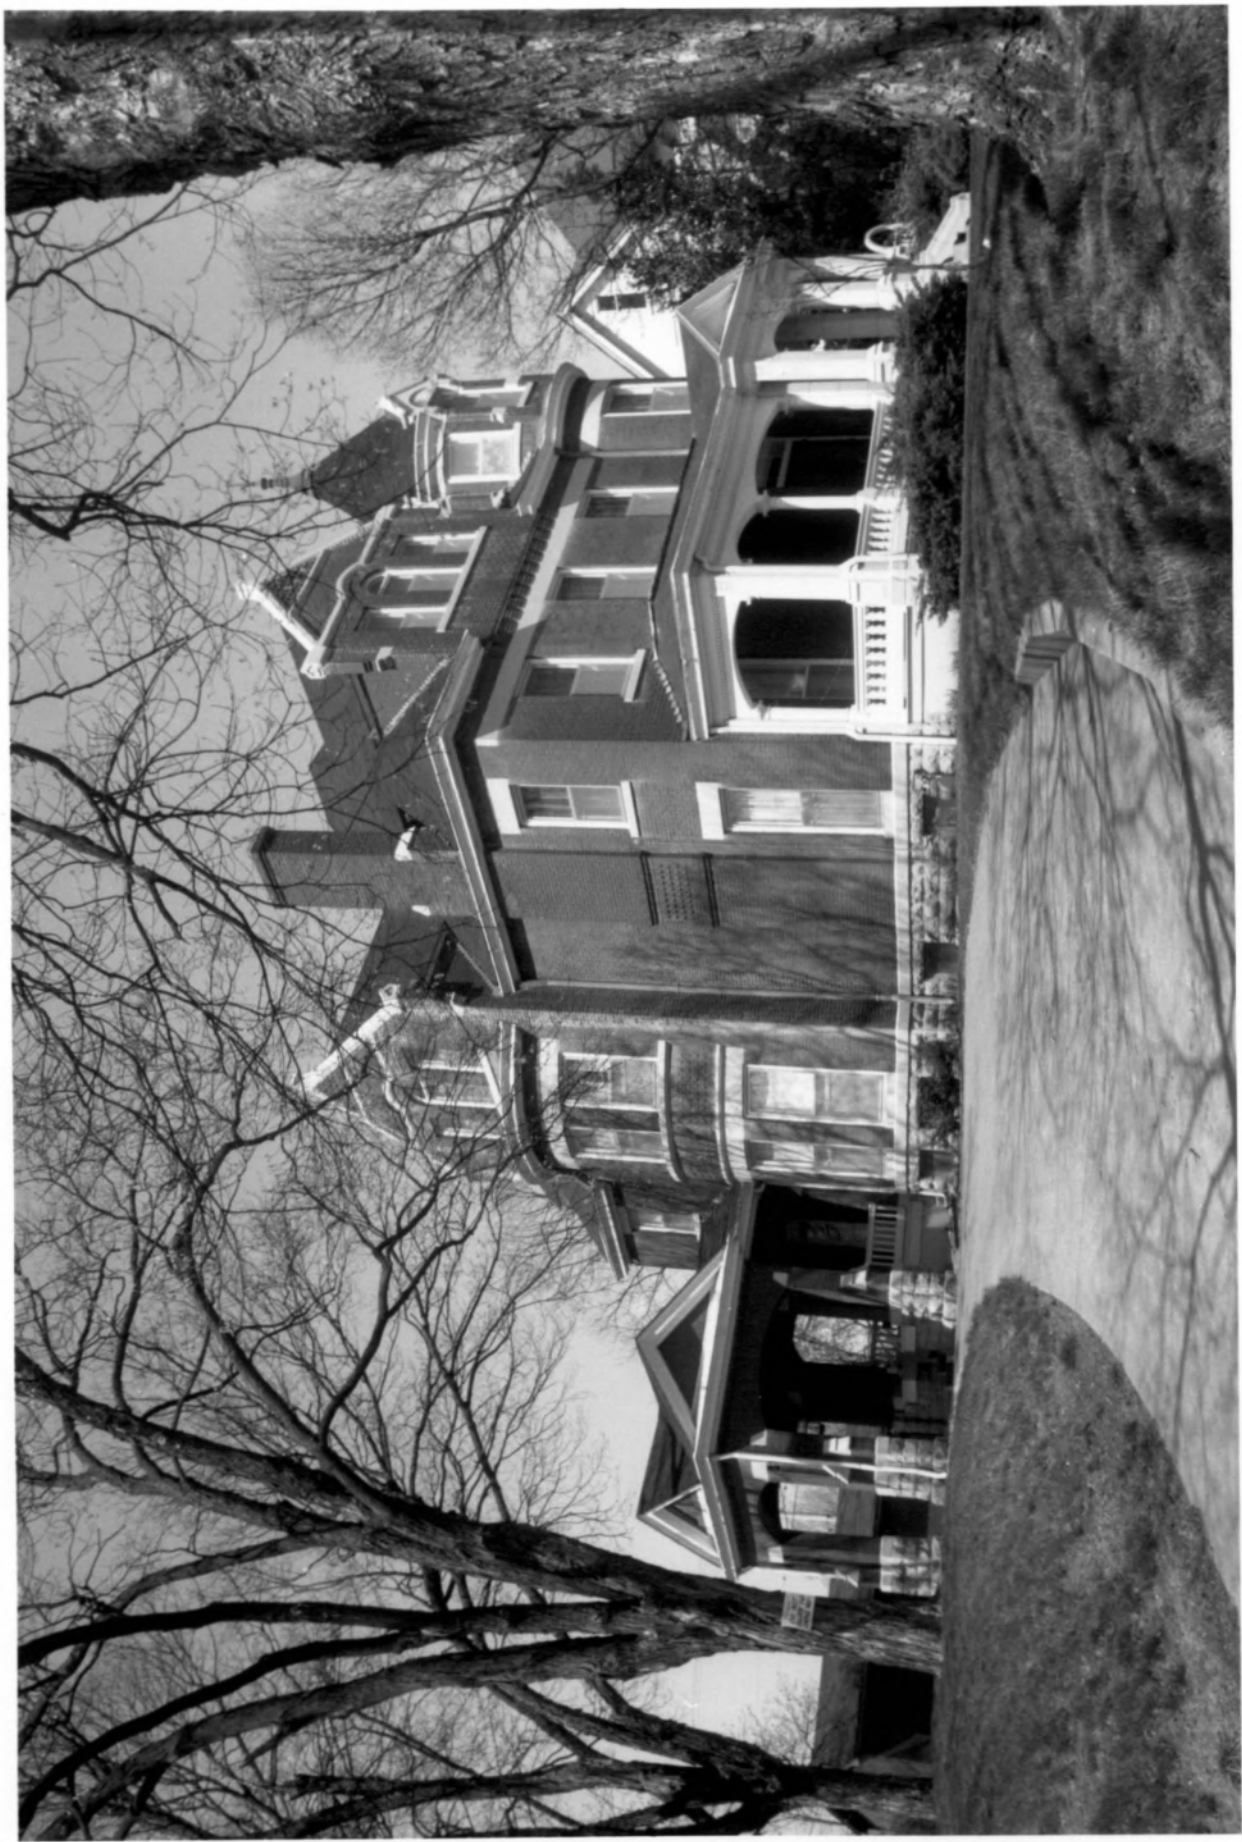
5 of 11

Missouri Cultural Resource Inventory
View from Southeast

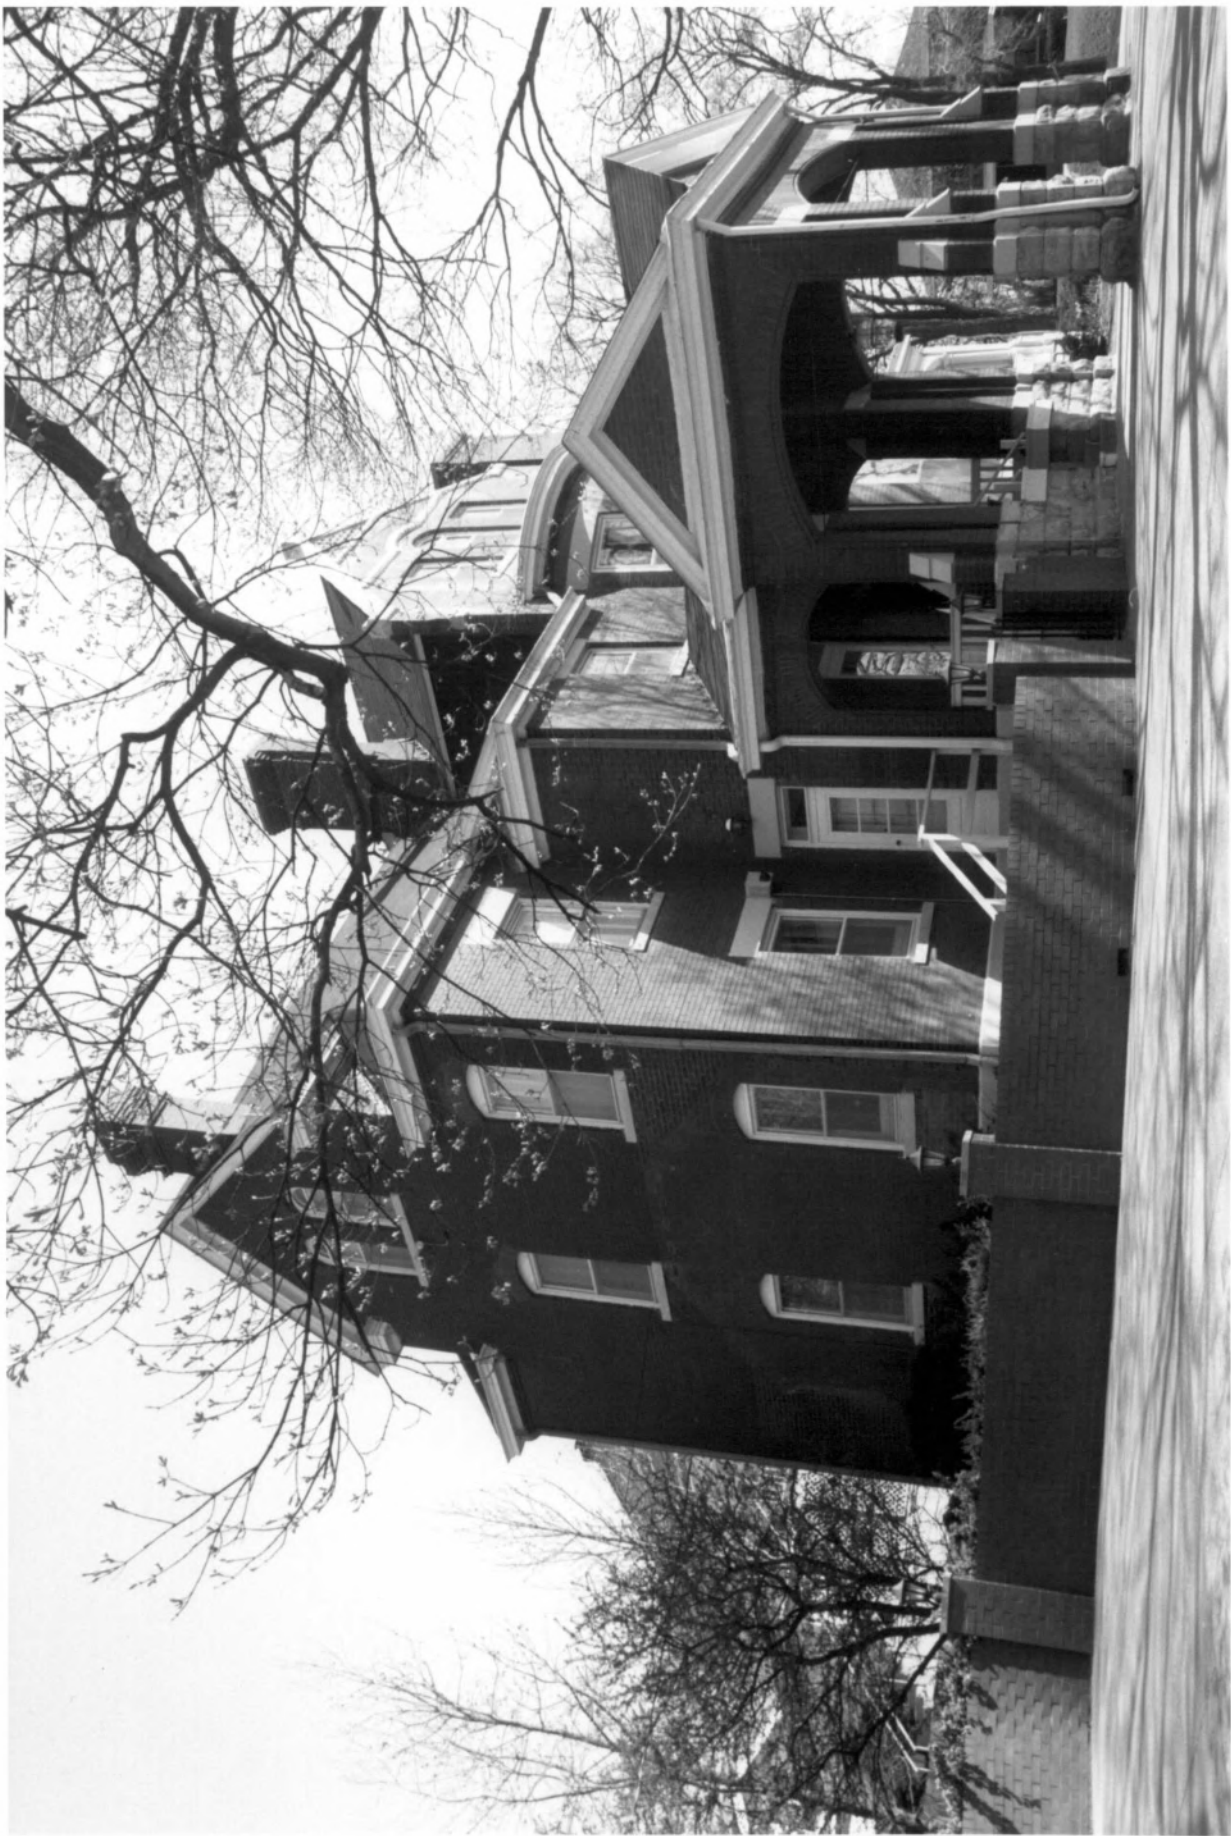
6 of 11

View from Southwest

The back of the house is plain with a solid brick wall breaking for a gabled dormer with two windows at the top. The window treatment is identical to the other three sides and common bond is used throughout. This facade contains the only alteration to the exterior of the building. A back porch was destroyed by fire at some point in the past and was not rebuilt. A door leads to the basement from this facade.

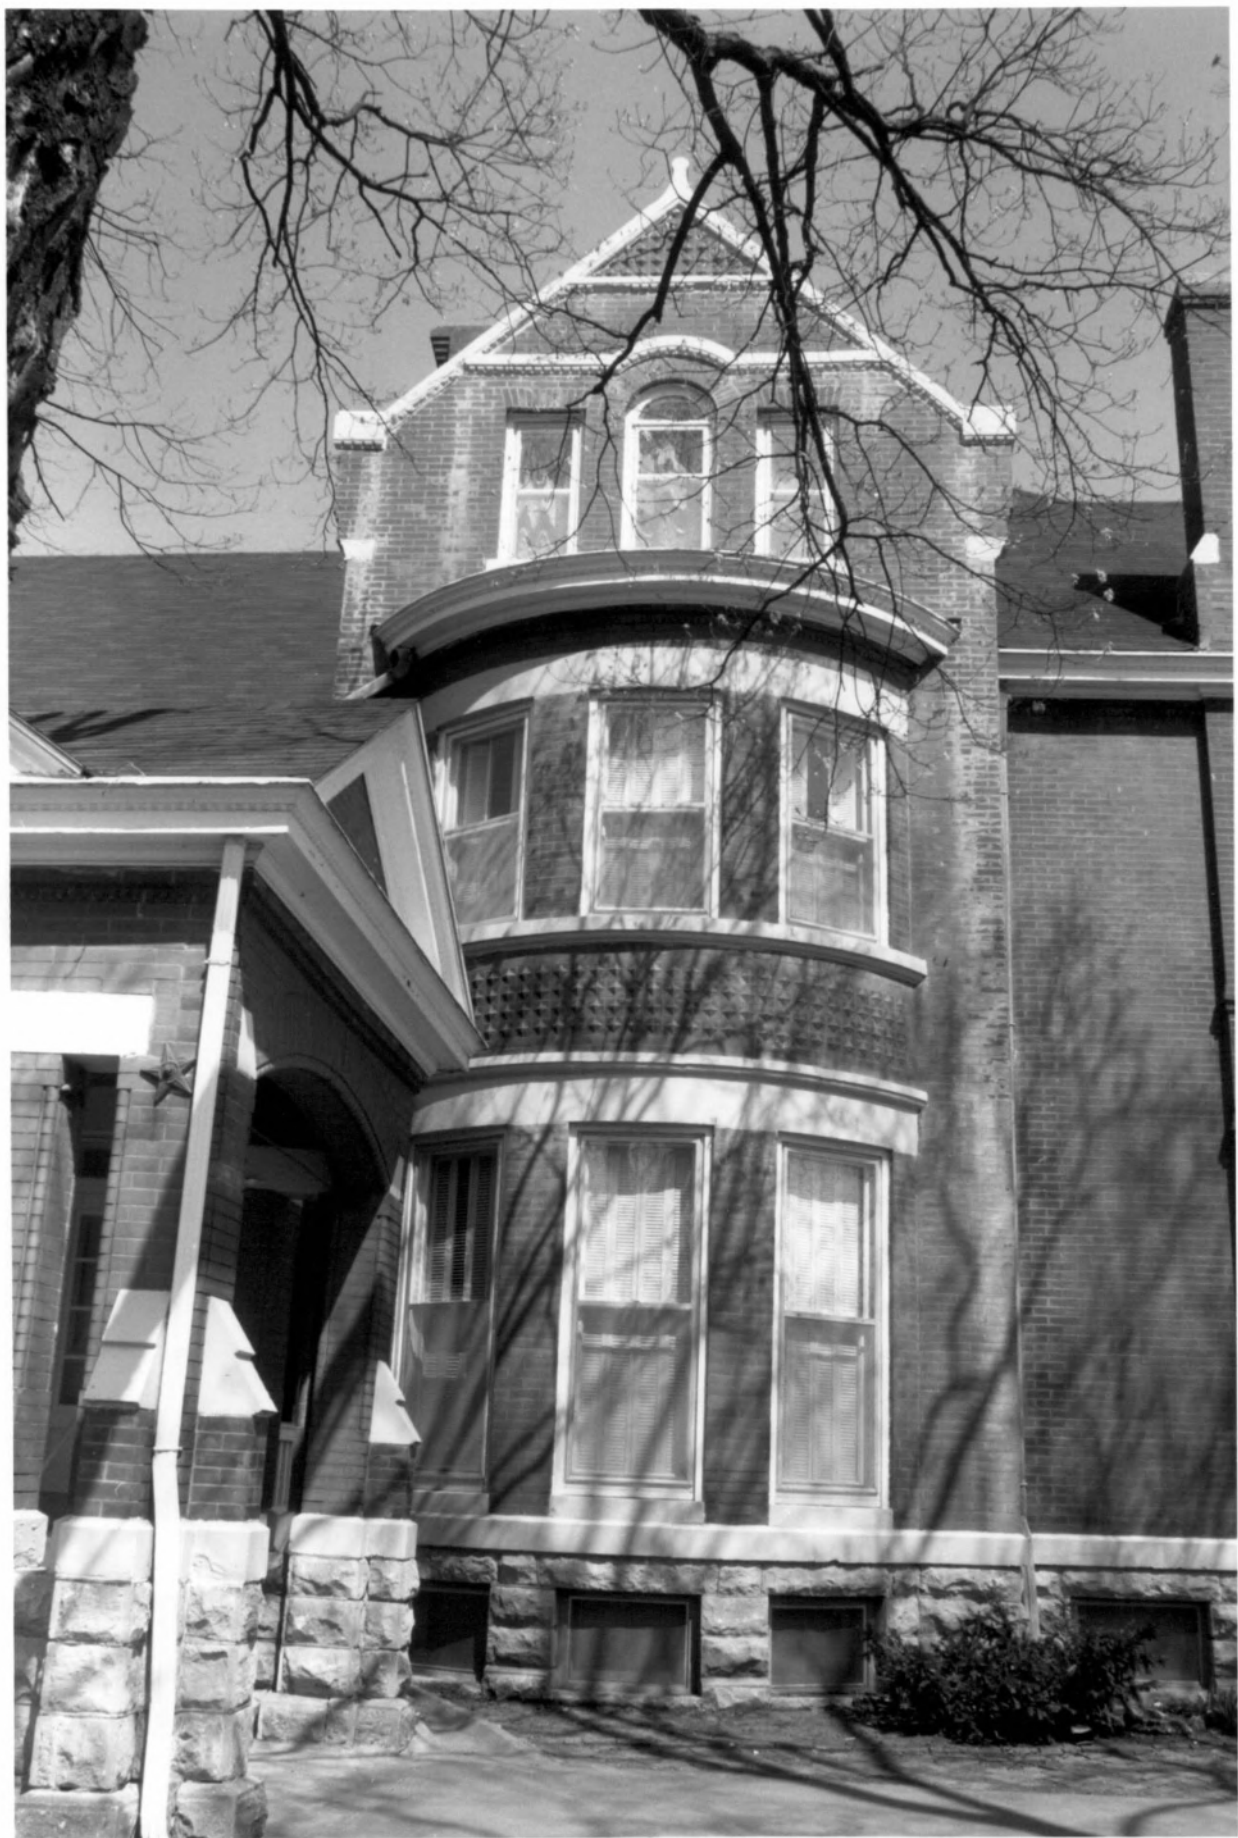
7 of 11

Detail of south elevation, view from the South

The south elevation has a large chimney, a two-story bow window, and a secondary entrance which is afforded protection by a hip roofed porte-cochere. The porte-cochere has segmental arches with Moorish decorative elements which appear elsewhere in both the exterior and interior of the house. The gasoliers are original as is the brick sidewalk running along this facade. The two-story bow window contains diamond shaped brick imitating the wood decorative patterning of the Queen Anne style. The windows of the second floor match the rest of the elevations and the front facade. A third gabled dormer tops this facade. The large chimney repeats the design of the others in the decorative brick and corbelled top.

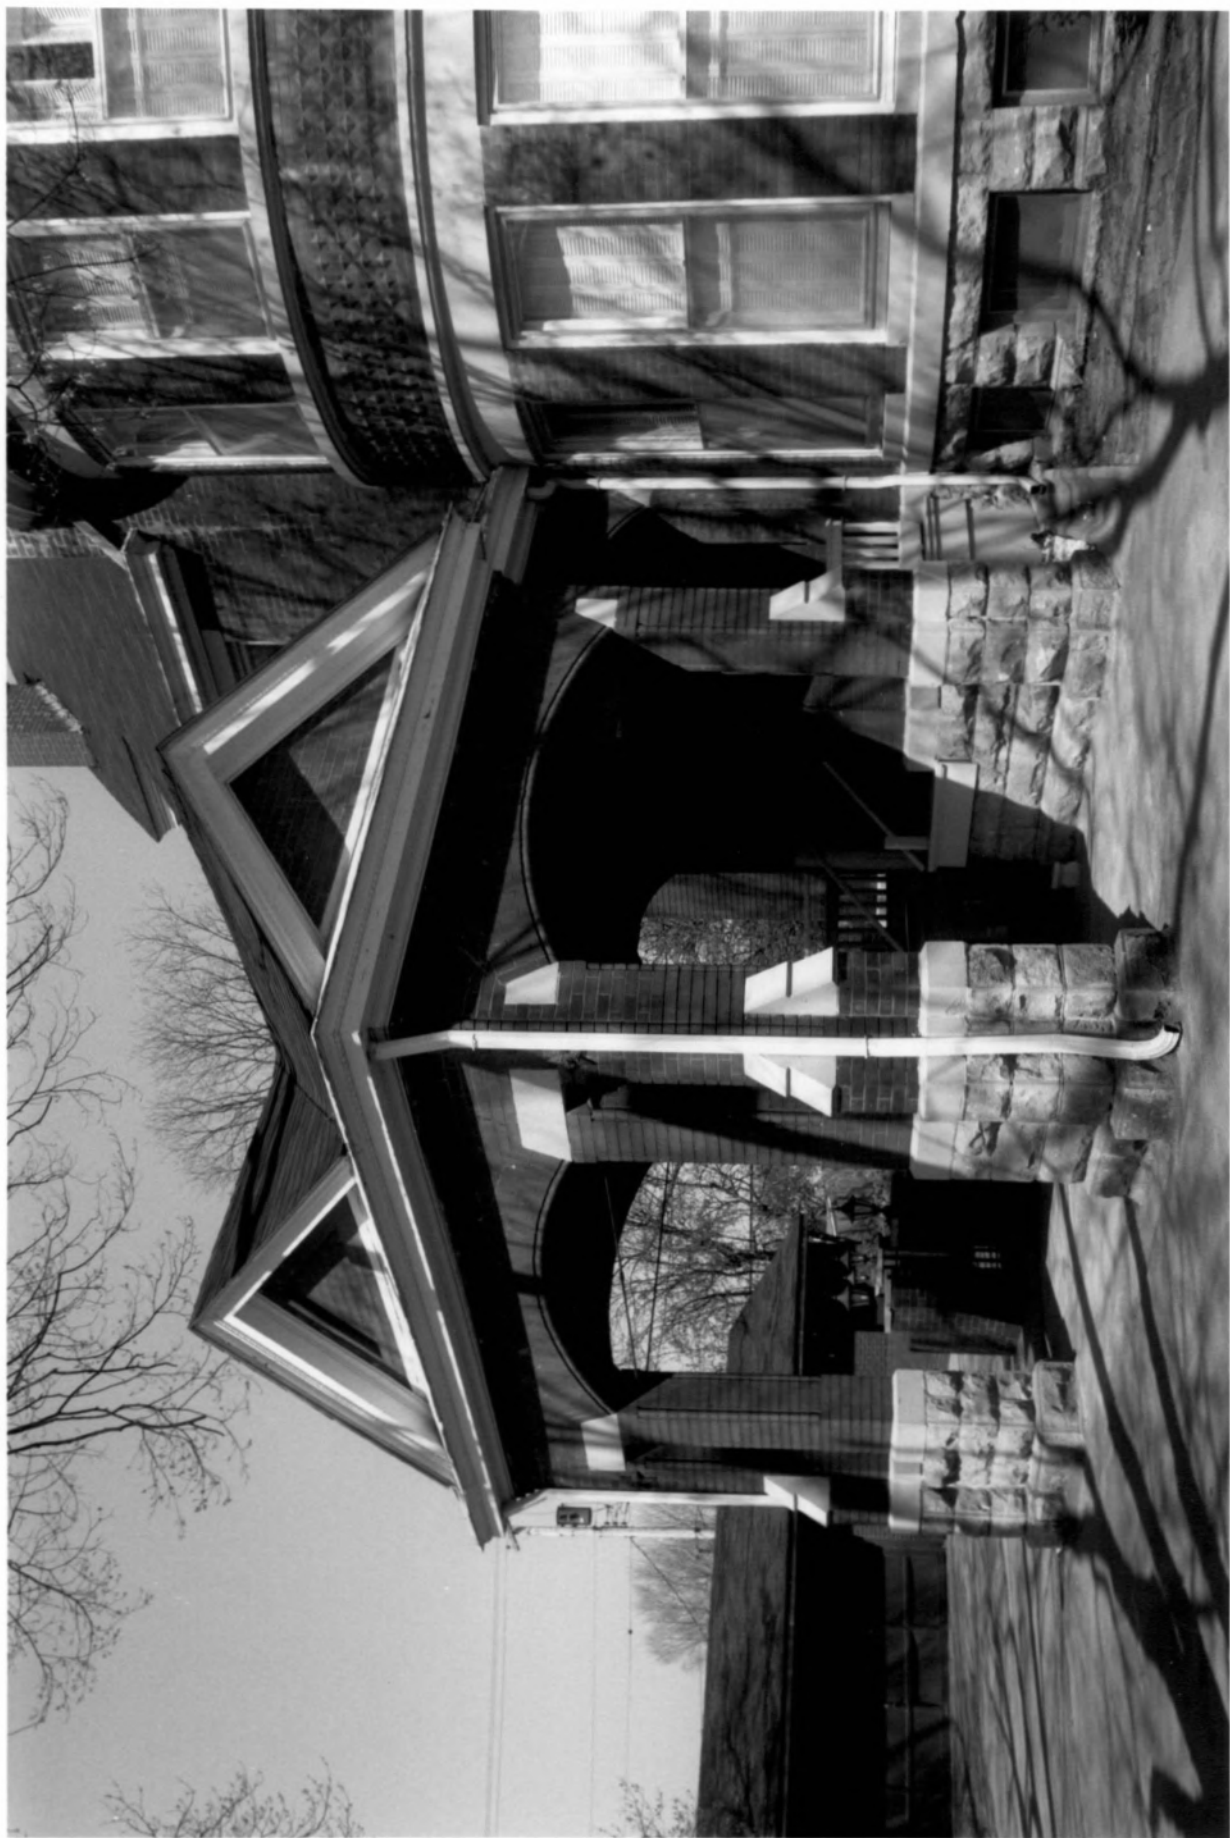
#8 of 11

Detail of porte-cochere, view from Southeast

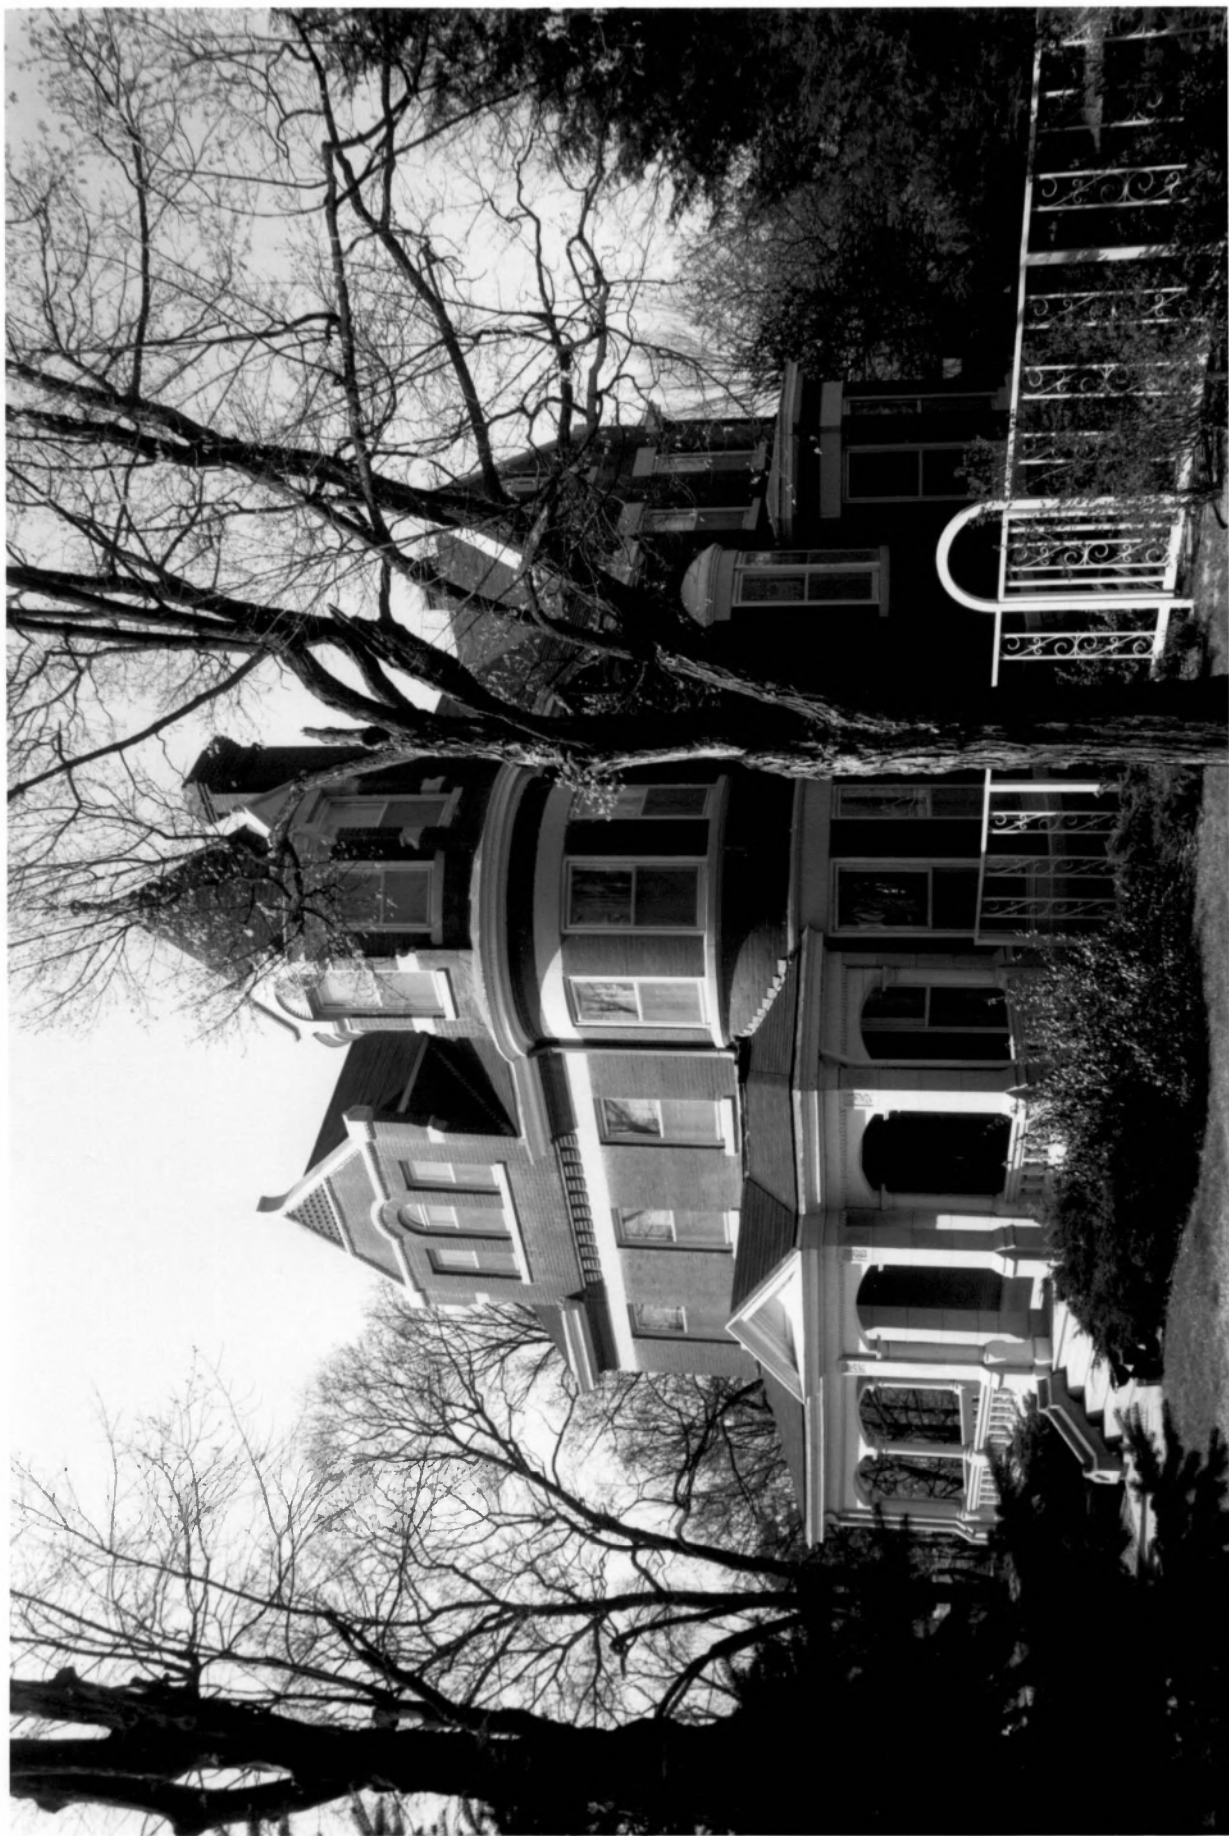
9 of 11

Missouri Cultural Resource Inventory
View from Northeast

Interesting features on the north elevation include an oriel window with a corbelled brick base and a one-story polygonal brick bay window. The second floor, as on the east elevation, has plain windows with stone lintels and lug sills. This elevation possesses a gabled dormer identical to the facade dormer. A corbelled brick chimney rises next to the tower.
